Inspection Report Minerals Regulatory Program

Mine Name: Papoose Operator Name: Cotter Corporation	Permit number: M0370084 Inspection Date: August 29, 2006 Time: About 5:15-6:30 PM Weather: Clear, 70s		
Inspector(s): Paul Baker Other Participants: None Mine Status: Active			
Elements of Inspection	Evaluated	Comment	Enforcement
 Permits, Revisions, Transfer, Bonds Public Safety (shafts, adits, trash, signs, highwalls) Protection of Drainages / Erosion Control Deleterious Material Roads (maintenance, surfacing, dust control, safety) Concurrent Reclamation Backfilling/Grading (trenches, pits, roads, highwalls, shafts, drill holes) Water Impoundments Soils Revegetation Air Quality Other Purpose of Inspection: This was a routine inspection. 			
Inspection Summary:

M0370084, Papoose Mine, Cotter Corporation

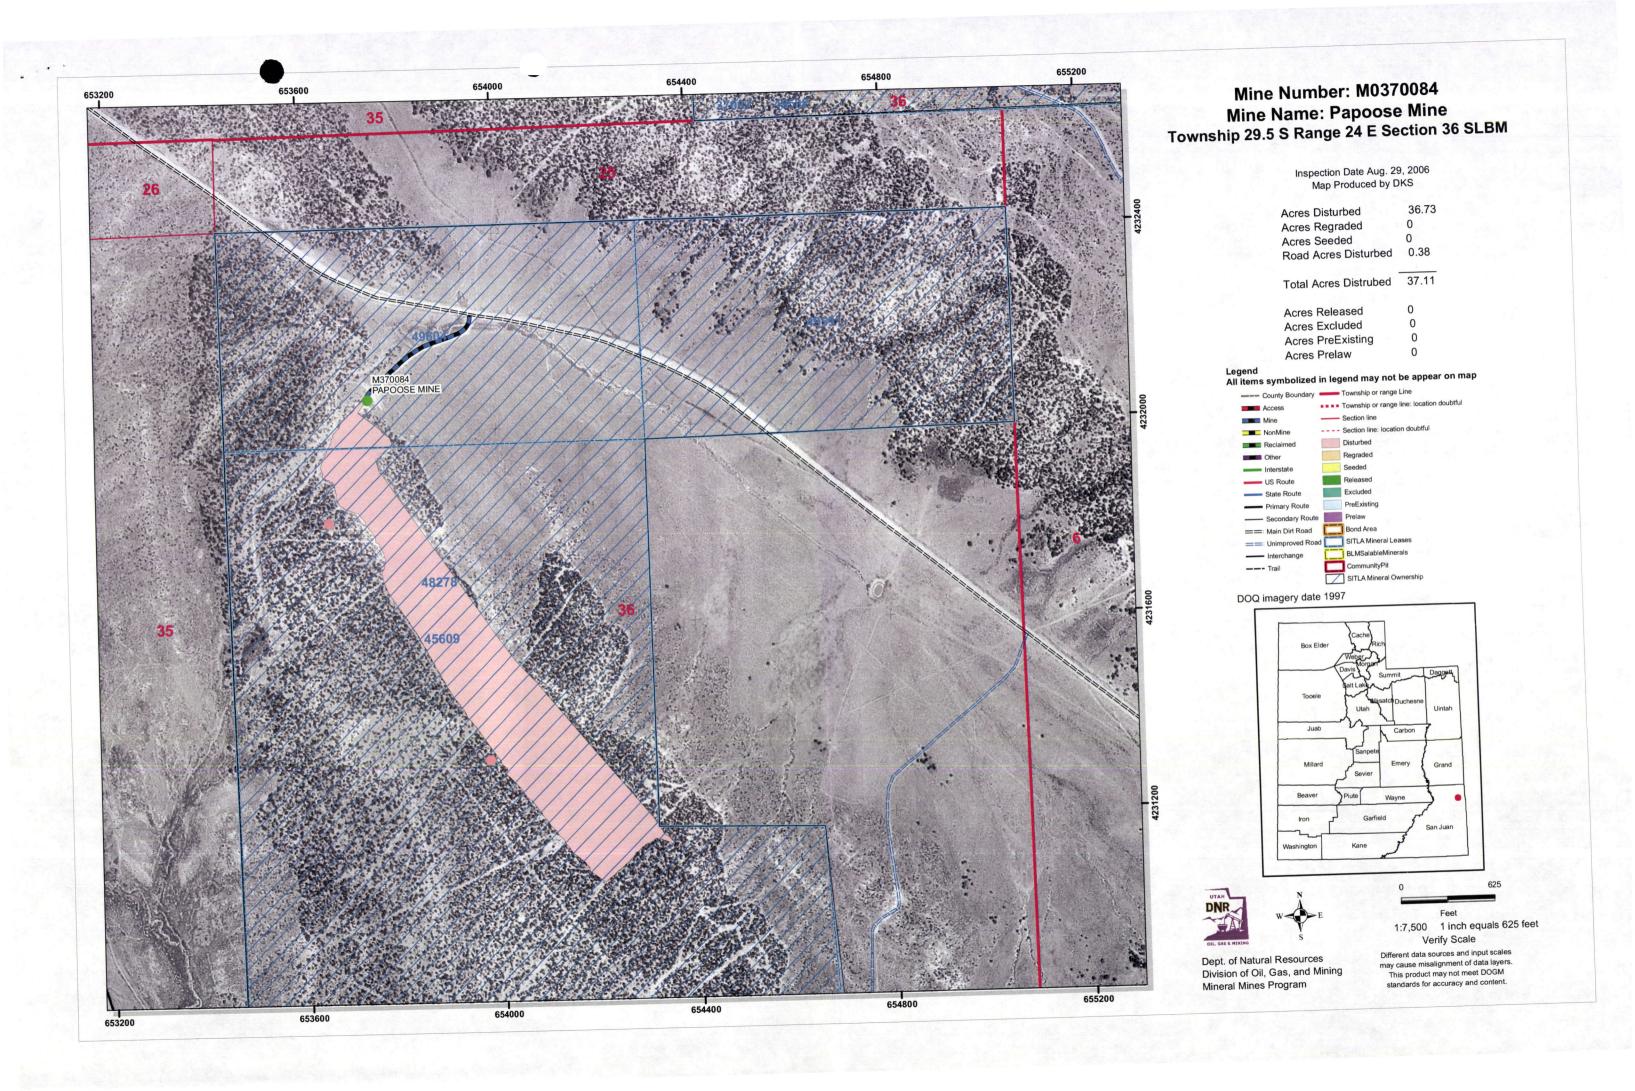
Soils are stockpiled on the northeast and southwest sides of the mine, and the operator has recently been clearing a new area and stockpiling these soils. Vegetation on the soil stockpiles consists almost entirely of Russian thistle.

Photo 5. The new area being cleared.
